# Transportation Route Shifts Impacts on The Deterioration of Facades in Kalimas Timur

Stefani Widya Agustianti<sup>1</sup>, Stephanus Wirawan Dharmatanna<sup>2</sup>

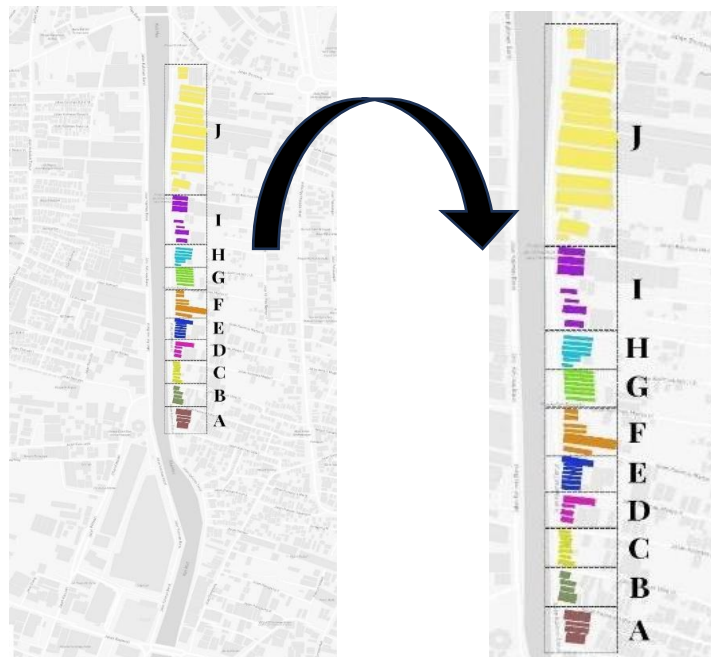
**Figure 4.** Section of Kalimas Timur Street to analyse the Condition of Facade Maintainability

Figure 4 is a key plan of the Kalimas Timur Street segment section for a detailed explanation of facade maintenance on each building. Kalimas Timur Street is divided into ten segments consisting of A. The segments are divided based on the gap between building facades. Each facade is discussed for its integrity, building elements and surface condition to assess the level of maintenance of each building. Below is a table that explains the level of maintenance of each building on Kalimas Timur Street.
