# Transportation Route Shifts Impacts on The Deterioration of Facades in Kalimas Timur

Stefani Widya Agustianti<sup>1</sup>, Stephanus Wirawan Dharmatanna<sup>2</sup>

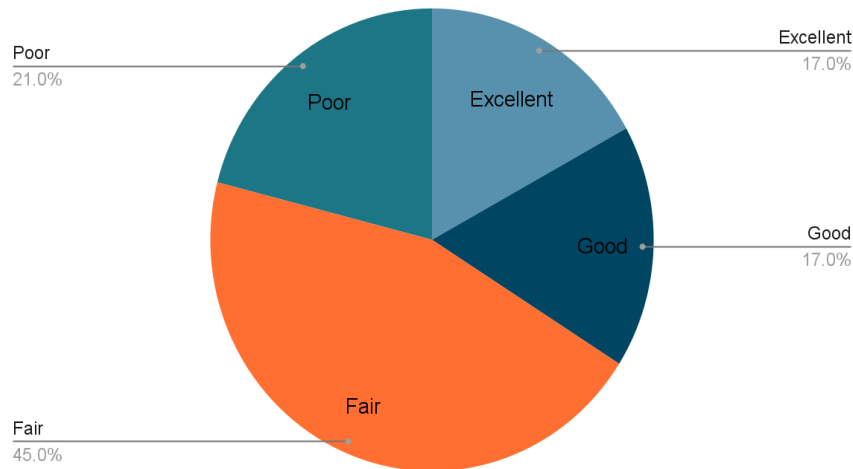
**Figure 5.** Percentage of Facades by Maintenance Level Classification on Kalimas Timur Street

Based on Table 3, the condition of the facades on Kalimas Timur Street is maintained at 45%. Reasonably maintained and poorly maintained facades account for 66% more than goodly maintained and excellently maintained facades, which account for only 34%. Poorly maintained buildings are dominated by former warehouses, where, in the past, the area was used as a trade transportation route via waterways. The location of Kalimas Timur Street, which is on the side of Kalimas River, has been affected by the change in the main transportation route of Surabaya City from waterways to roadways. As a result, Kalimas Timur Street, which used to be an important area of the city, has now become an underdeveloped area. The change in transportation routes affects the facades of buildings near the waterway, which tend to be shabby and poorly maintained.
